PHOTOGRAPHIC INTERPRETATION REPORT

STATUS OF NORTH VIETNAM  
SAM SITES

NPIC/R-20/66  
JANUARY 1966

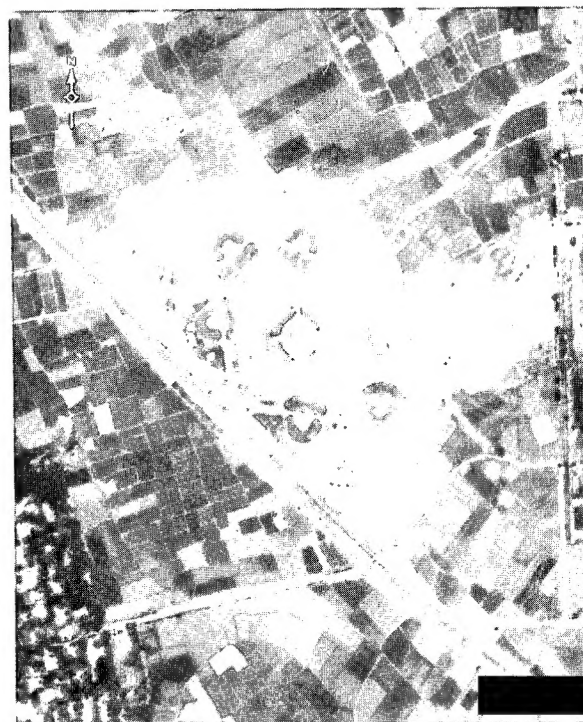
FIGURE 1. CONSTRUCTION OF HANOI SAM SITE B21-2.

From a detailed study of available photography of all SAM Sites in North Vietnam, it is concluded that all revetments, and the base of the revetment where the launcher is to be positioned, are of earthen construction. Many of the revetments analyzed have been constructed by scraping up earth in the immediate area of the site to form the walls, as is observed at Hanoi SAM Site B21-2 in its construction sequence between [REDACTED] (Figure 1).
